<b>Title</b> <b>Hollow core slabs in the assembly process – structural behaviour and strength during positioning of elements</b>	<b>Report No.</b> 1-23
	<b>Date</b> 24 January 2023 Rev. 16 June 2023
<b>Authors</b> Terje Kanstad, Daniel Cantero, Martin Kristoffersen and Guomin Ji	<b>Sign.</b>
	<b>No. of pages</b> 47
ISBN 978-82-7482-203-0

<b>Summary</b> <p>A series of laboratory and full-scale tests were carried out to study the structural behaviour of hollow core slabs in the assembly stage. The main objective for the project is to establish a basis for and evaluate the current regulations and practice concerning allowance of work at story levels below floors where hollow core slabs are being assembled.</p> <p>The laboratory test program included material testing, static standard shear capacity tests of hollow core elements, static and impact tests of hollow core cut-outs (<math>b/h/L = 0.4, 0.265, 2.3\text{m}</math>), and full-scale tests with falling single hollow core elements (<math>L = 10\text{m}</math>) on a hollow core slab with grouted joints. The test results showed that the grouted and anchored HC slab has sufficient strength to withstand the load case.</p> <p>The struct

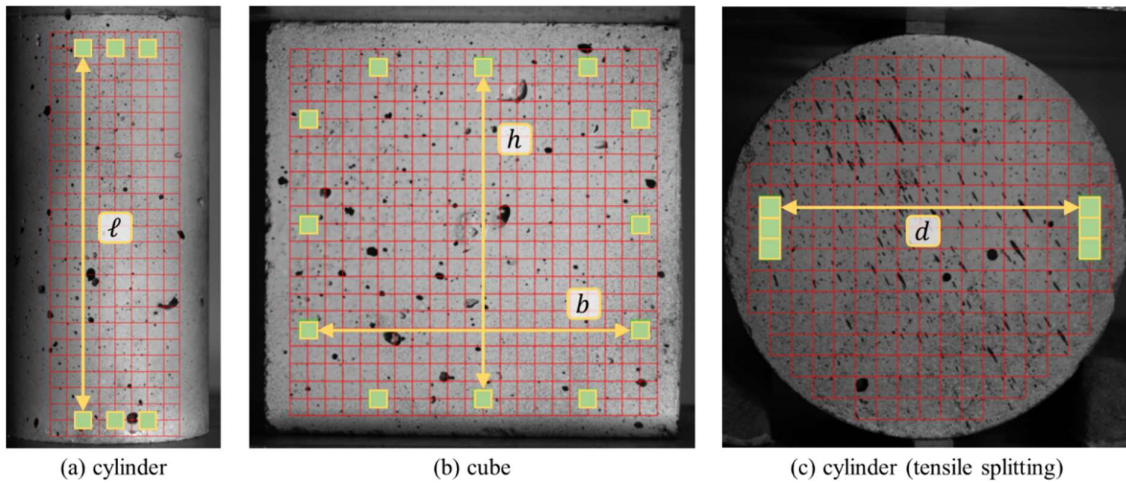
Figure 1: Measurements using subsets in the DIC code eCorr [2].

in which subscript “0” indicate initial values of the corresponding measurement. The engineering stress  $S$  is found by dividing the logged force by the initial cross-sectional area  $A_0$  across which the load acts. The resulting engineering stress-strain curves are thus shown in Figure 2. The data shown are the averages of the strain as measured by three subset pairs as indicated in Figure 1.

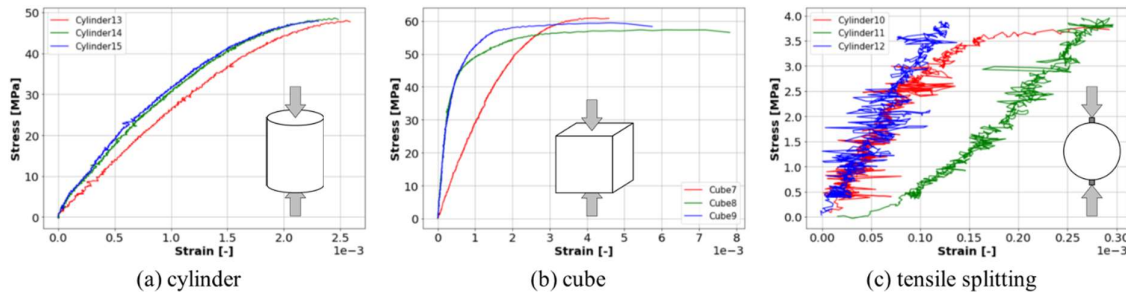
Figure 2: Engineering stress-strain curves obtained from DIC for (a) cylinder compression tests, (b) cube compression tests, and (c) tensile splitting tests.

Naturally, some noise is present in these measurements because the deformations are so small. For the compression tests in Figure 2(a) and (b) there is some noise, but it is very small compared with the tensile splitting data in (c). The noise is much more pronounced in the latter because the tensile strains are one order of magnitude lower compared with the compressive strains.

As observed from Table 1 and Figure 2, the data produced appears consistent and reproducible. An exception might be cube 7 in Figure 2(b), but this could be caused by misplaced subsets and warrants further investigation. The tensile splitting curves are naturally more scattered. It is, however, the peak load that is of interest in this case, and the peak load is quite consistent. For now, we conclude that the compressive strength is consistent across the specimens and sample dates. Average values of the tests performed around 28 days after casting can be found in the bottom row of Table 1.

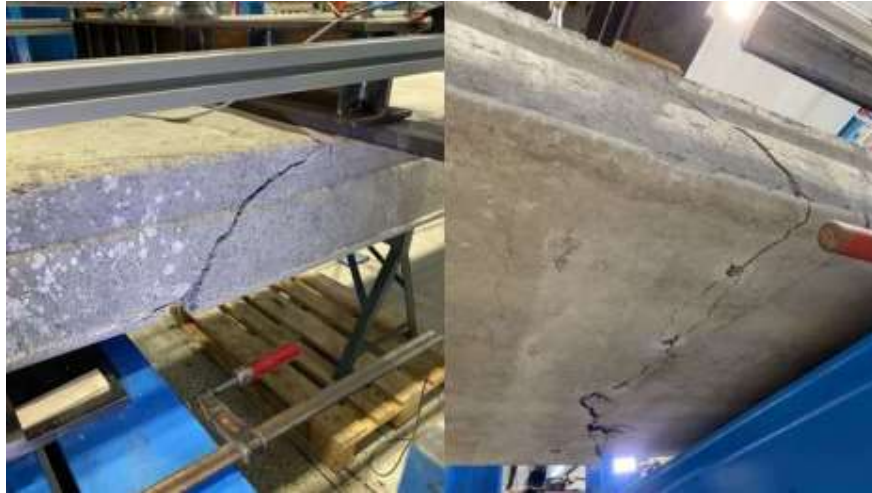
Figure 4: Observed cracking after failure shear failure of HC element testing

The same test was repeated for two identical elements. In both elements shear failure was observed for values of the load equal to 219 kN and 204 kN. The elements after failure displayed a major crack going from the line of load to the underside of the element near the support (see Figure 4). The observed crack pattern could be defined as the typical shear failure. The reported capacities and failure mechanisms were as expected, confirming that the prefabricated elements had been fabricated according to the standard. The experimental results are compared to capacities according to Eurocode 2 in Section 3.1.

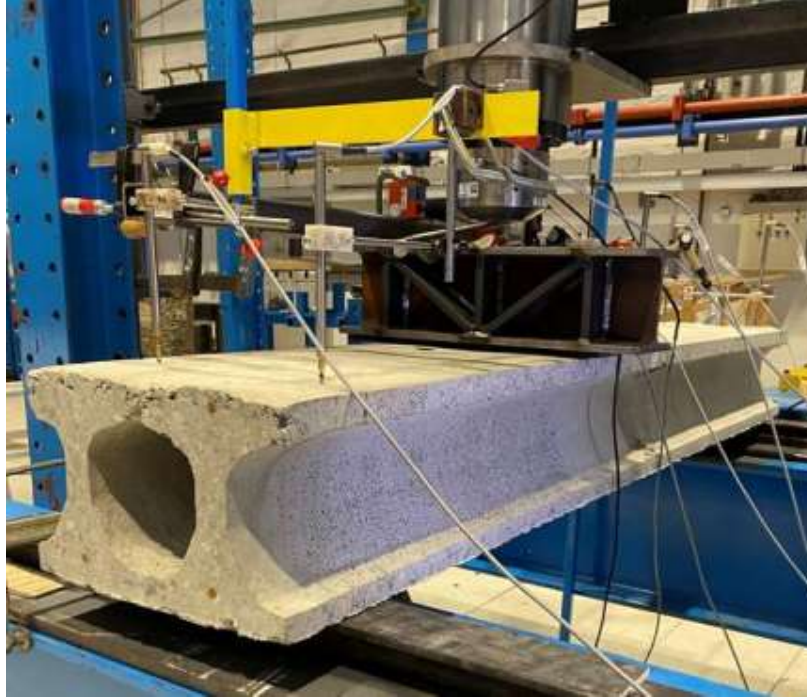
*Figure 6: Static test set-up of cut-out element*

The cut-outs were positioned in a simply supported configuration for the static tests (Figure 6). The testing equipment applied a quasi-static (slowly increasing) load from the loading cell with a rounded tip to the tested element. The rate of load increase was constant throughout a single test. To ensure that no dynamic effects were observed during the testing slow loading rates and displacement control were used (10 mm/h to 20 mm/h). The load was increased until the element failed. Vertical displacements were measured at 8 different locations using LVDTs located at sections at the supports, near the loading point and at mid-span. Also, the testing equipment provided the applied load and vertical displacement

at the load. In addition, a camera was used to record an area near the support where the shear cracks were expected to appear. The processing of the video by digital image correlation (DIC) was used to map the cracking of the element.

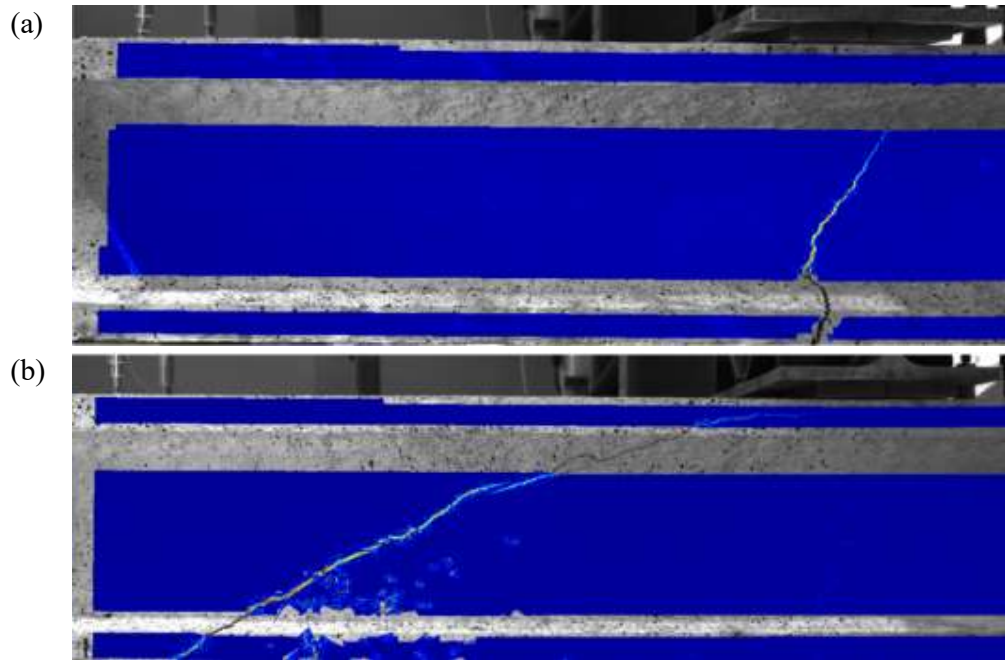
*Figure 8: Crack pattern examples for (a) Bending failure of element ID02;  
(b) Shear failure of element ID04*

Figure 8 shows examples of crack distributions at the instance of failure as extracted by DIC. Test ID02 had a clear bending failure, while almost for the same load test ID04 presented a clear shear failure (x1 in Figure 7 reduced from 2.5h to 2.18h).

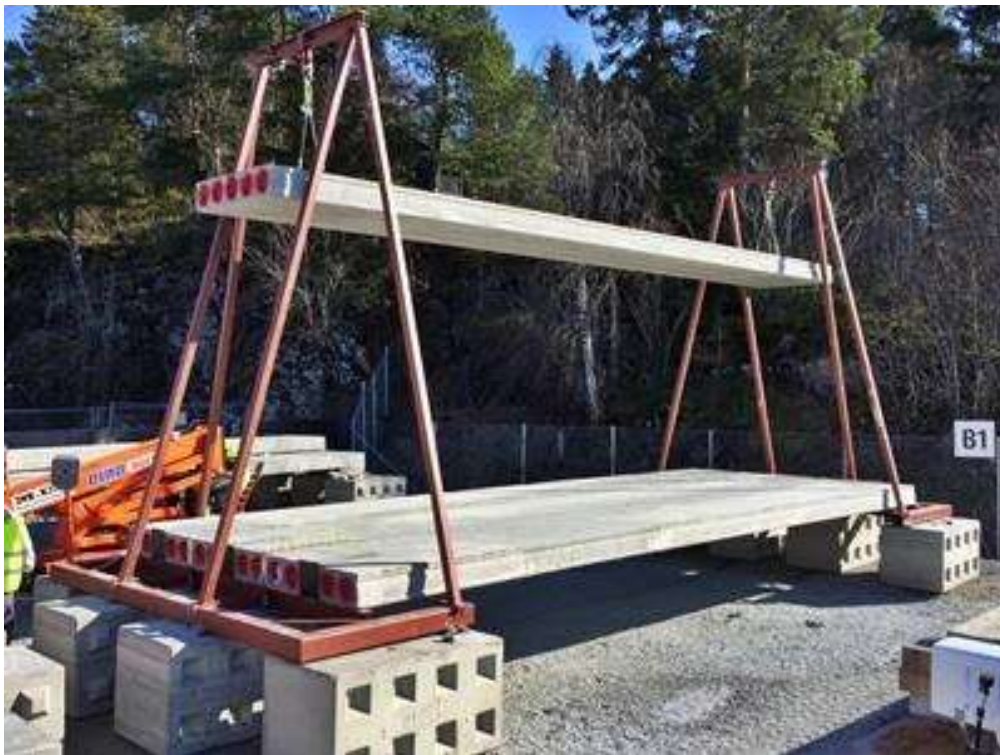
*Figure 12: Overview of full-scale experimental set-up*

The full-scale tests took place at the premises of Contiga AS (Stjørdal). The intention of the tests was to study a possible construction accident with typical hollow core slab (HCS) dimensions, story-height, span-width, and boundary conditions. There were also some similarities to the reported accident in Trondheim in 2012. The idea was to study the structural behaviour and failure mechanisms of a single hollow core element falling over a finished floor. The floor consisted of 3 HC elements spanning 10 m. The two joints between the elements were grouted one week before testing. In addition, the floor was connected to the supports by a grouted connection between protruding steel bars from the supports encased around recesses at the HC ends. The falling HC element was positioned over the floor at a typical floor height, hanging from a steel frame rig (See Figure 12).

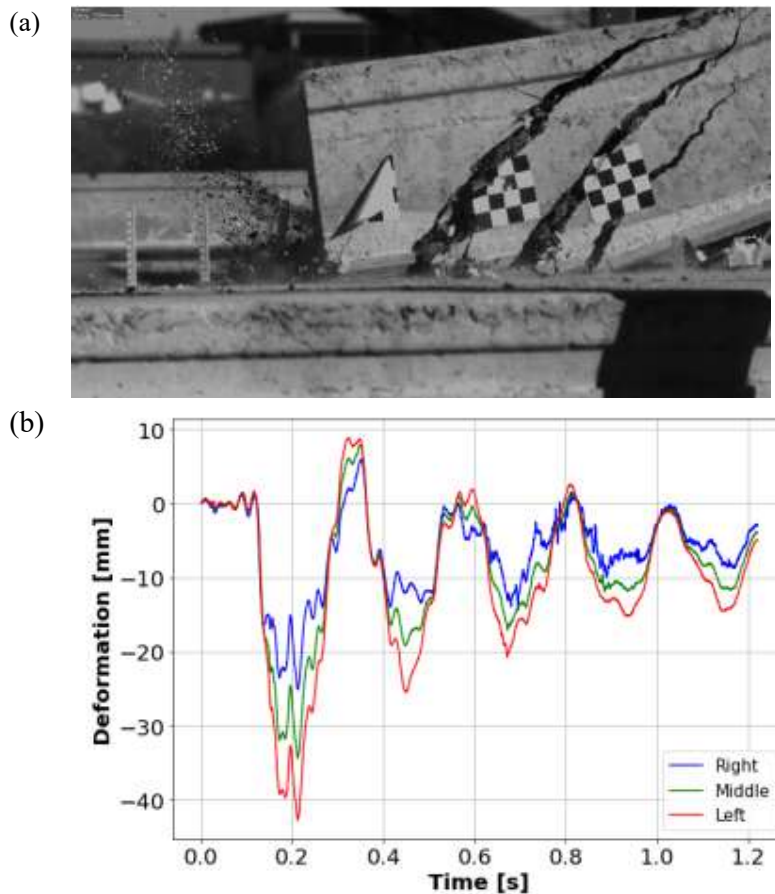
Figure 14: (a) Instant of appearance of the 3<sup>rd</sup> crack on the falling element in T1F1; (b) Vertical deformations in time of various sections in the floor during T2F2. The sections Right, Middle, Left refer to the view in Figure 13.

For T1F1 and T2F1 the impact was close enough to the floor edge and within the range of the grouted area of the support. This might explain why no damage was observed, since that region of the floor is stronger. But also T3F1 showed no indication of damage, even when the impact was further away of the stronger grouted support connection. However, even if the floor presented no obvious damage, it might have cracked during the impact and restored immediately after the impact. Therefore, there might be some hidden damage and reduced capacity of the floor after the first fall. The experiment was not designed to be able to assess the remaining capacity of the floor after the first impact. Nevertheless, the good condition assessed by visual inspection of the floor after the first fall indicates that there was extremely low probability of the floor collapsing after the first fall.

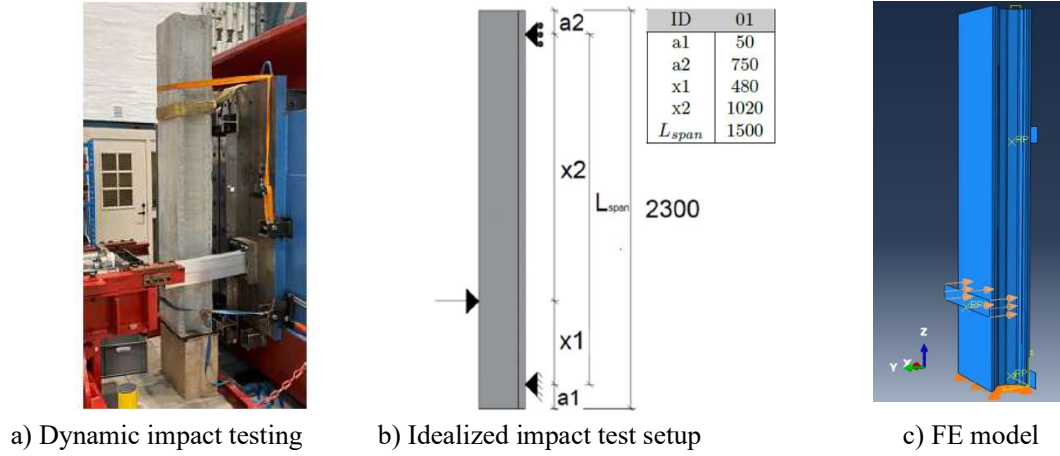
Figure 20: Hollow core slab in dynamic impact test

The dynamic impact test setup and the FE model are shown in Figure 20. The strain rate dependent material properties according to CEB-FIP Model Code 90 as shown in Figure 21 were used in the simulations.

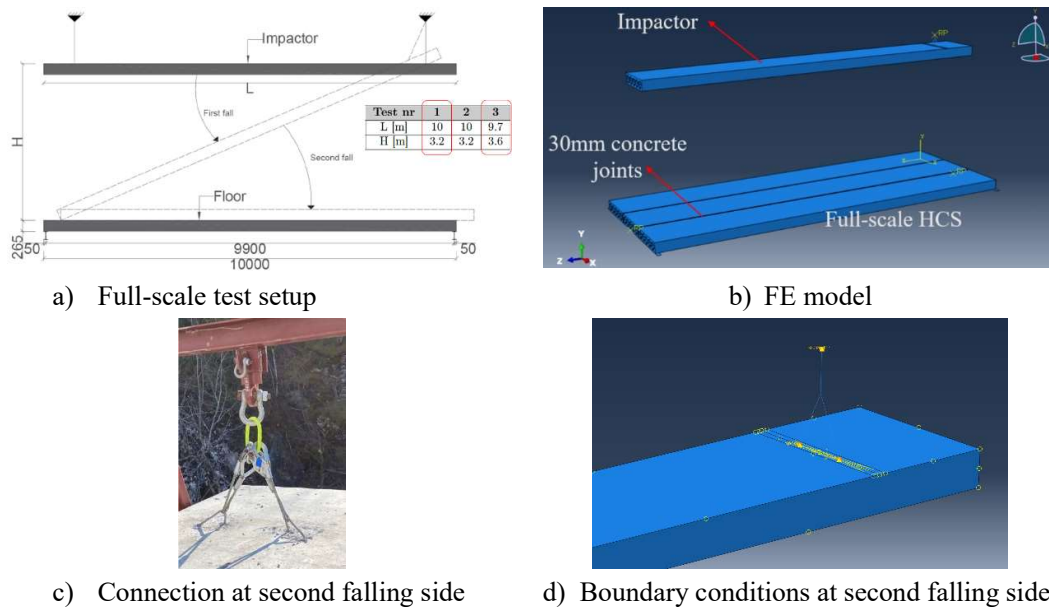
Figure 22: Full-scale test of hollow core slab (HCS)

The full-scale test setup and the FE model are shown in Figure 22. The boundary condition of the impactor at the second falling side has a great influence on the impact point. In the FE model the chain connection at second falling side was modelled using truss elements. The predicted distances between the impact point and the end of the floor slab are shown in Figure 23, and the measured and predicted distances for both test T1 and T3 have good agreement with the experiments as shown in Table 8.

The floor had three hollow core slabs which were grouted together by concrete joints with 30 mm width at the top. Contact cohesive behaviour is defined as a surface interaction property, and it is used to model the bonded interface between the concrete joints and the HCS with the possibility of damage and failure of the bond. To achieve similar robustness as in real cases, the middle channel of the hollow core slabs was grouted over a certain length at both ends.

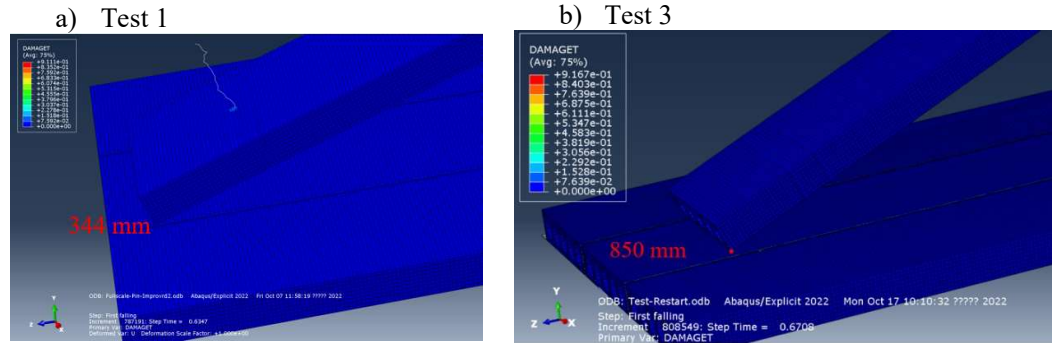
Figure 23: The distances between the impact point and the end of the floor slab predicted by the simulations.

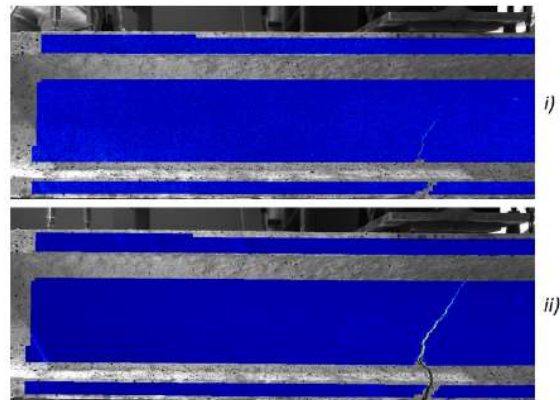
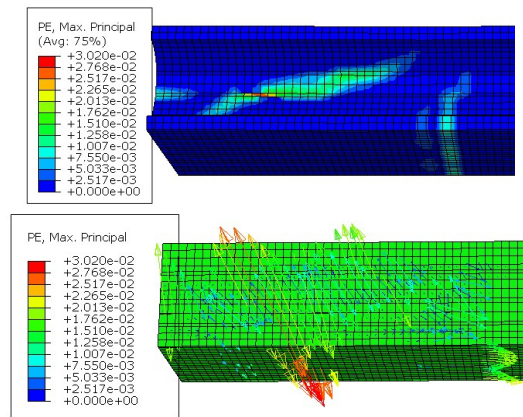
a) Load and displacement curves (HD01 and HD02)

b) Strains recorded by DIC illustrating cracking and moment failure occurring in HD01(upper) and HD02.

c) Size and direction of the maximum principal strains at moment failure in the static analysis

d) Size and direction of the maximum principal strains at combined moment and shear failure from the Quasi-static analysis.

Figure 25: The load-displacement curves and failure patterns of the HC cut-outs according to static tests and maximum principal strains from the numerical simulations (HD01 and HD02)

The load-displacement relationship from the static (implicit) and the quasi-static (explicit) analyses are shown in Figure 25a)-Figure 28a) where they are compared with the test results. Although predicting the post-failure behaviour is difficult, the results are in reasonable agreement with experiments. The deviations before the 1<sup>st</sup> crack is probably due to tightening of the connection in the test rig system.

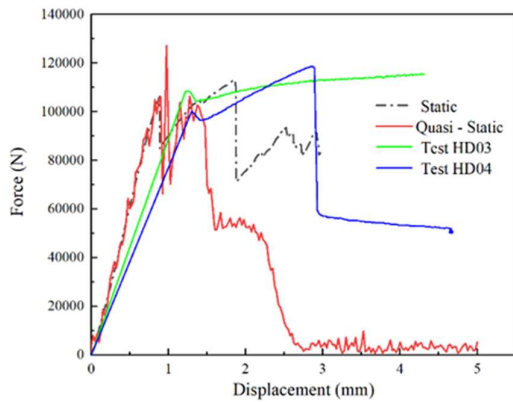
a) Load and displacement curve (HD03 and HD04)

b) DIC recorded strains in test HD03 illustrating cracking and moment failure

c) Recorded strains in HD04 getting combined moment and shear failure

d) Size and direction of the maximum principal strains at combined moment and shear failure (static analysis)

e) Size and direction of the maximum principal strains at combined moment and shear failure (Quasi static analysis)

Figure 26: The load-displacement curve and failure pattern of HCS according to static tests and simulations (HD03 and HD04)

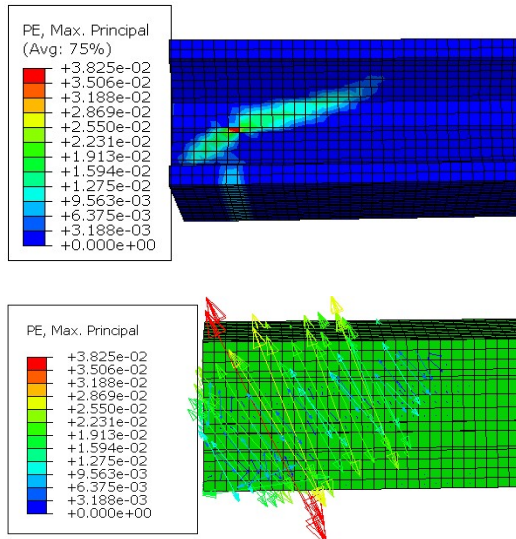
a) Load and displacement curve (HD07 and HD08)

b) Cracking recorded by DIC in test HD07 where shear failure occurred

c) Size and direction of the maximum principal strain at shear failure in the static analysis

d) Size and direction of the maximum principal strain at shear failure from the Quasi static analysis

Figure 28: The load-displacement curve and failure pattern of HCS according to static tests and simulations (HD07 and HD08)

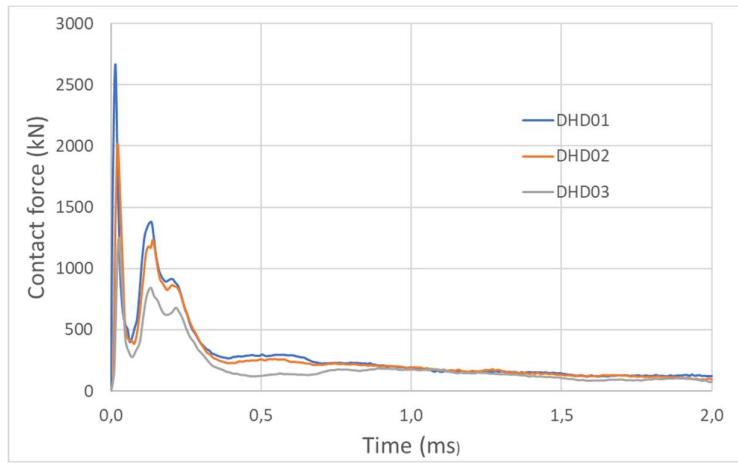
*Figure 32: Contact force of the impact plate from the simulations*

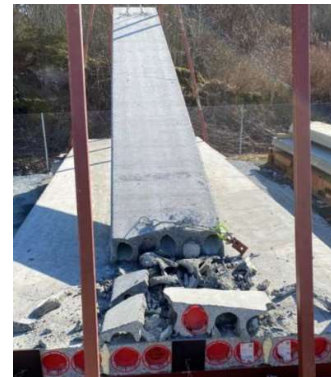
f) The front of impactor after the first impact

Figure 33: Comparison between simulation and test for the impactor after the first fall for full-scale test 1 (TIF1)

The comparisons of the simulation and the first full-scale test after the first impact (T1F1) are shown in Figure 33 and Figure 34 for the impactor and the floor slab respectively. From the first figure it is seen that relatively good agreement between test and simulation is achieved for the failure pattern of the impactor. In the test the floor slab did not show visible damage at the top surface of the impact area after the first impact while the simulation results showed minor damage at the top surface of the middle element and also some damage in the web and on the bottom surface of the middle element of the floor after first impact.

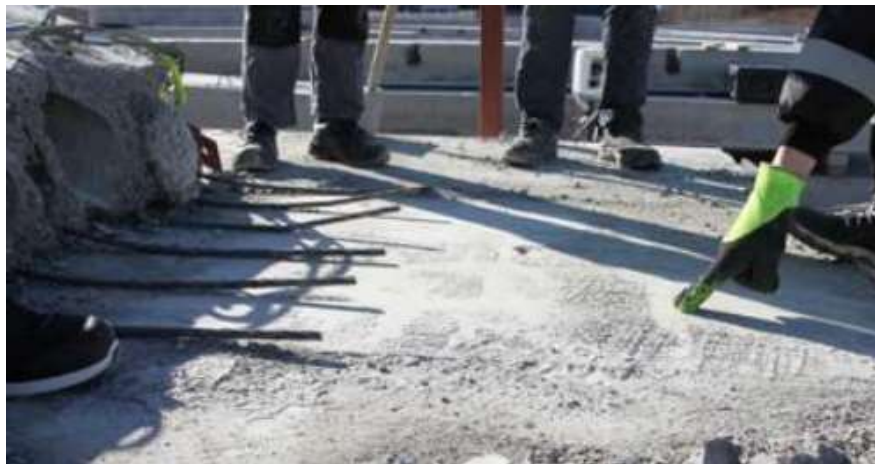
e) Top surface of the impact area after the first impact

Figure 34: Comparison between simulation and test for the floor slab after the first fall for full-scale test 1 (TIF1)

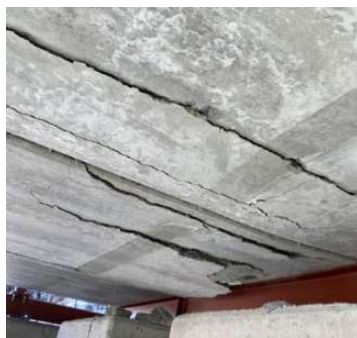
c) Area around the support at right side after the second impact

*Figure 35: Comparison between simulation and test after the second fall for the full-scale test 1 (TIF2)*

The comparisons of the simulation and the first full-scale test after the second impact (T1F2) are shown in Figure 35.

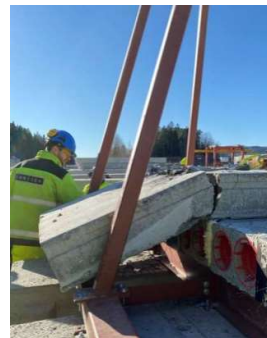
d) The end of impactor after the second impact

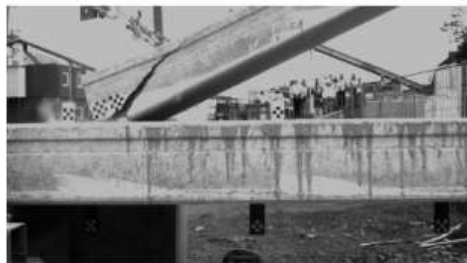
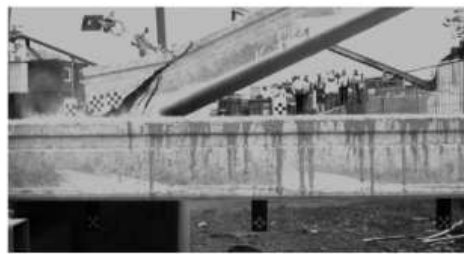
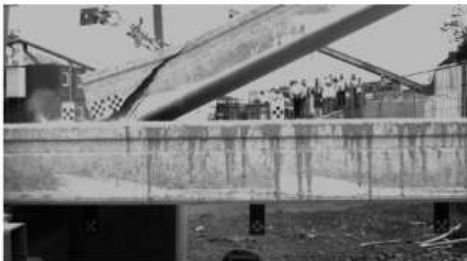
Initial crack

End of first impact

Second crack

e) Crack development in the impactor during the first impact

*Figure 36: Comparison between simulation and test after the first fall for full-scale test 3 (T3F1)*

The comparison of the simulation and the third full-scale test after first and second impact (T3F1 & T3F2) are shown in Figure 36 and Figure 37 respectively. The top surface of the impact area did not show visible damage after the first impact which agrees with the simulation results. The deformation predicted by simulation has good agreement with the measured one from test at location 3.75 m from left support as shown in Figure 38.

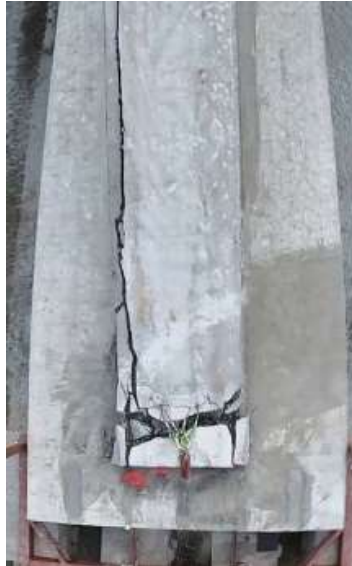
f) The end of impactor after the first impact

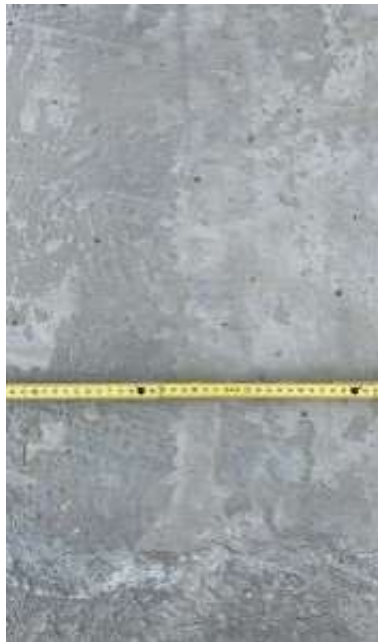
g) Top surface of the impact area after first impact

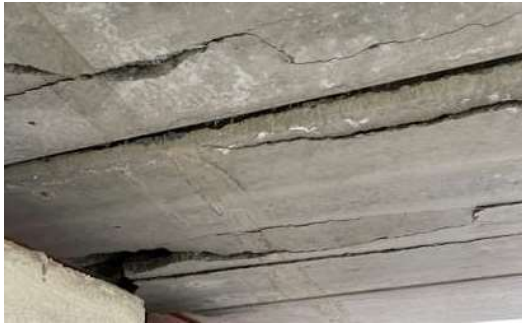
c) The area close to the support at right side after second impact

Figure 37: Comparison between simulation and test after the second impact for full-scale test 3 (T3F2)

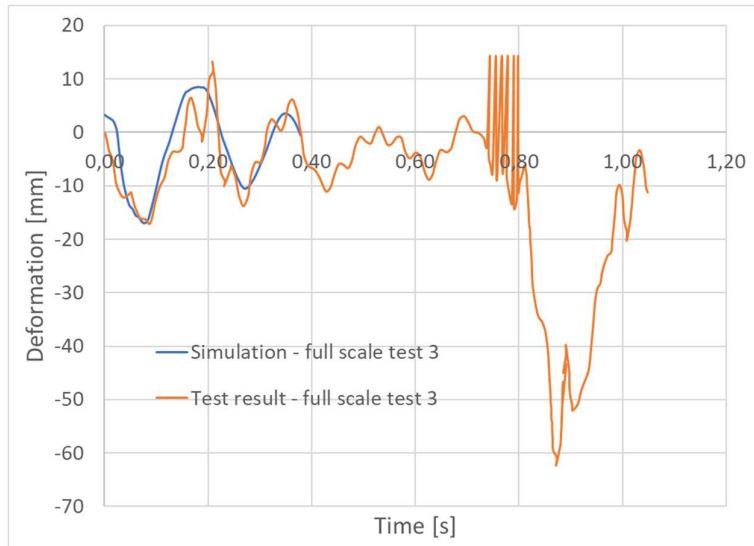
Figure 38: The deformation at location 3.75 m from the left support
